⑥ National Dam Inspection Program
Star Junction Number 1 Dam
(NDI Number PA-00198, PennDER
Number 26-30) Ohio River Basin,
Washington Run, Fayette County, Pennsylvania.

Phase I Inspection Report

STAR JUNCTION NO. 1 DAM
FAYETTE COUNTY, COMMONWEALTH OF PENNSYLVANIA
NDI NO. PA 00198
PennDER NO. 26-30

Prepared by: ACKENHEIL & ASSOCIATES GEO SYSTEMS, INC.
Consulting Engineers
1000 Banksville Road
Pittsburgh, Pennsylvania 15216

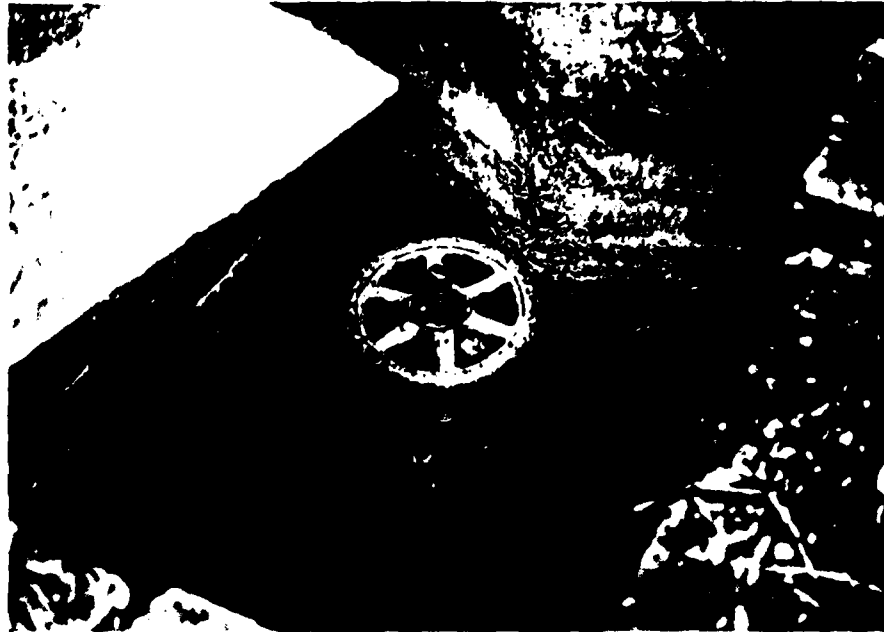
e. Outlet Works: Four gate valve pits were observed at the locations shown on the Field Plan in Appendix A. The three visible valves were not activated. Several water supply pipe lines were observed inside and adjacent to the outside of the ruined concrete block structure. No pipe leakage was observed.

PHOTO 9. FLOODED GATE VALVE CONTROL CHAMBER,
NORTHWEST SIDE OF CHLORINATION HOUSE

(c) Investigation of the outlet works with specific recommendations on making them operable and including provisions for upstream flow controls.

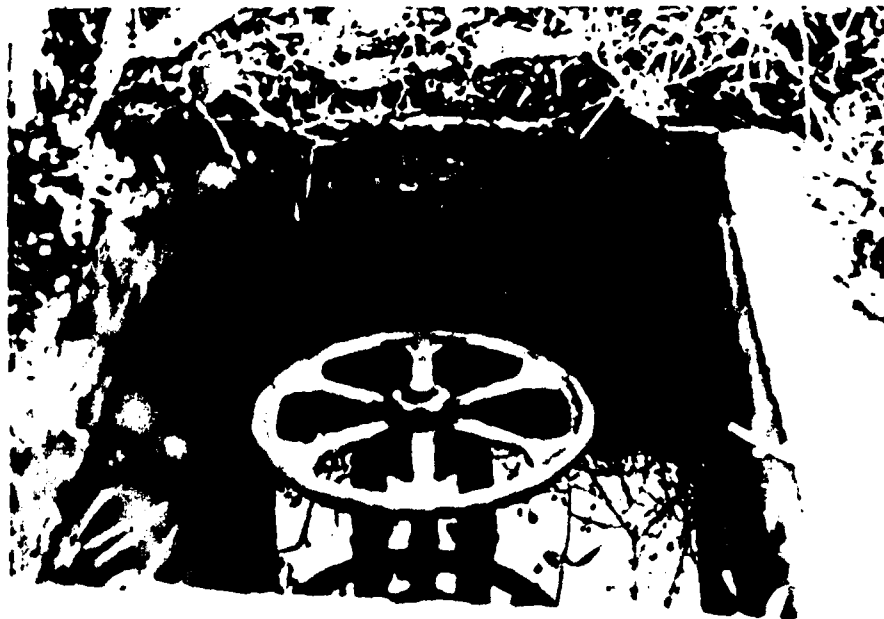
PHOTO 10. FLOODED GATE VALVE CONTROL CHAMBER BETWEEN
CHLORINATION HOUSE AND WATER STORAGE TANK
